**Re: West Cliff Colliery, Longwall 38 End of Panel Report - Aboriginal Heritage Assessment**

# West Cliff Colliery, Longwall 38 End of Panel Report: Aboriginal Heritage Assessment

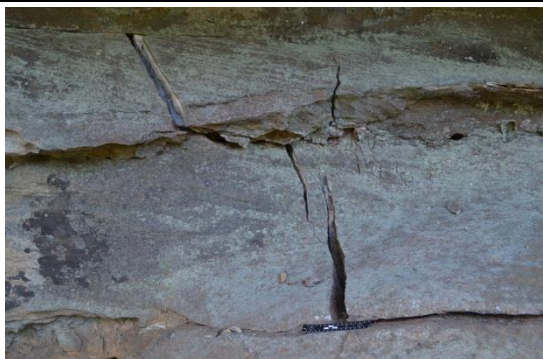
AHIMS site number	Site Name	Results of inspection	Photograph of current condition of site
52-2-2243	Georges River 2	Impacts to this shelter had been noted in Niche (2014). Observations found that impacts had not increased and remained in the same condition as described by Niche in 2014, due to the extraction of Longwall 36. The Thin, vertical cracking previously observed in the shelter roof to the right side of the art panel remains the same as previously described.

<p>Northern end of shelter examples of horizontal and vertical cracking that remain the same as previously described.</p>

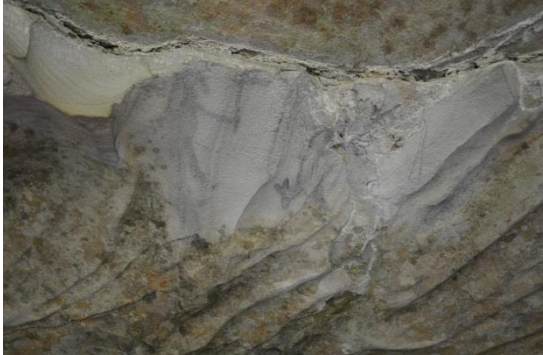
AHIMS site number	Site Name	Results of inspection	Photograph of current condition of site
		<p>The cracking does not appear to have altered seepage or water movements in the shelter, and there is no evidence of water flow or recent micro-vegetation growth associated with the cracking.</p> <p>The art panel remains in the same condition as described in Biosis Research 2007 and Niche 2013b, 2014, 2015 and has not been affected by the observed changes.</p>

<p>Picture of art panel still in same condition as described by Biosis 2007, Niche 2013b and 2014</p>

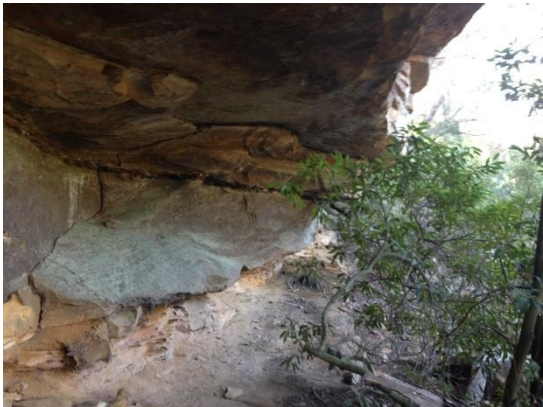
<p>View of the shelter facing north. Same as depicted by Biosis 200, Niche 2013b and Niche 2014.</p>
52-2-2244	Georges River 3	<p>This shelter was in the same condition as described by Niche in 2014. There has been no further movement of the horizontal bedding plane joints of the shelter and the cracking and exfoliation observed in relation to Longwall 35. The site remains the same as previously described.</p> <p>The cracking does not appear to have altered seepage or water movements in the shelter, and there is no evidence of water flow or recent micro-vegetation growth</p>

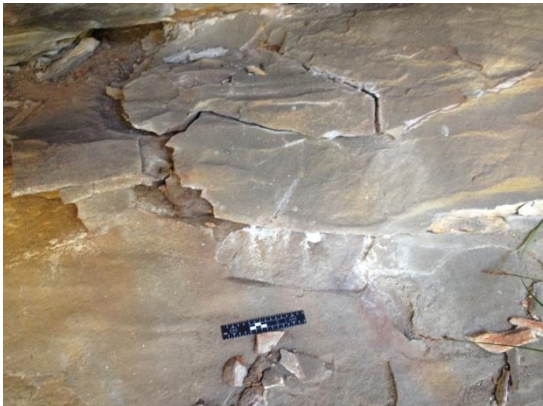
<p>Example of the cracking along the back wall of the shelter, in the same condition as depicted in Niche 2014.</p>

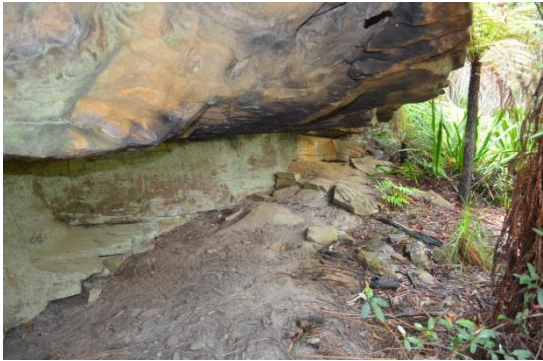
AHIMS site number	Site Name	Results of inspection	Photograph of current condition of site
		<p>associated with the cracking.</p> <p>The art panel remains in the same condition as described in Biosis Research 2007, Niche 2013b, 2014 and 2015.</p>	
52-2-2242	Georges River No 4	<p>Shelter and Art are in the same condition as described by Biosis Research 2007 and Niche Environment and Heritage 2011, 2013, 2014 and 2015. The art has started to loose granular substrate and there has been some cracking and flaking to the panel due to case hardening. Artefacts were not observed in the drip-line of the shelter.</p>

<p>52-2-2242 remains in the same condition as described and pictured 2007.</p>

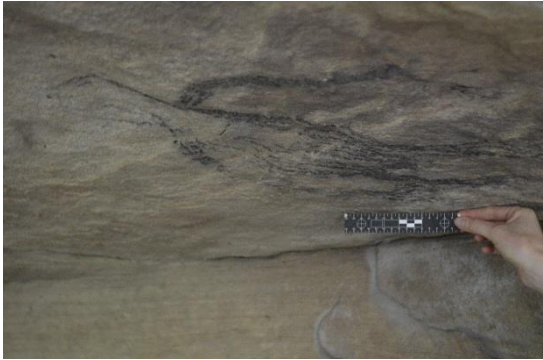
<p>Charcoal infill art present at 52-2-2242 remains in the same condition as described in Biosis Research 2007 and Niche Environment and Heritage 2013, 2014 and 2015.</p>

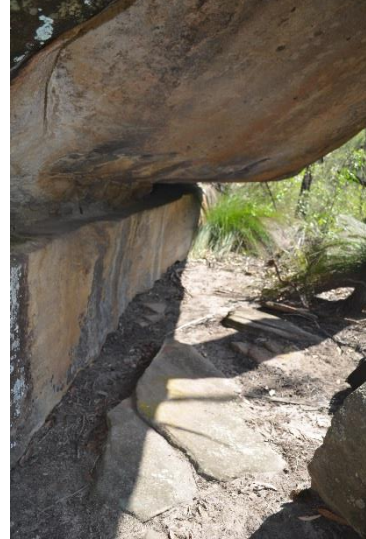
AHIMS site number	Site Name	Results of inspection	Photograph of current condition of site
52-2-2234	Georges River 1	<p>This shelter is in the same condition as previously described in both Biosis Research 2007 and Niche Environment and Heritage 2011, 2013, 2013b and 2014. Natural weathering of the art panel has caused further granular loss, and a white leeching process has occurred over the infill kangaroo.</p>

General photograph facing north of Georges River 1

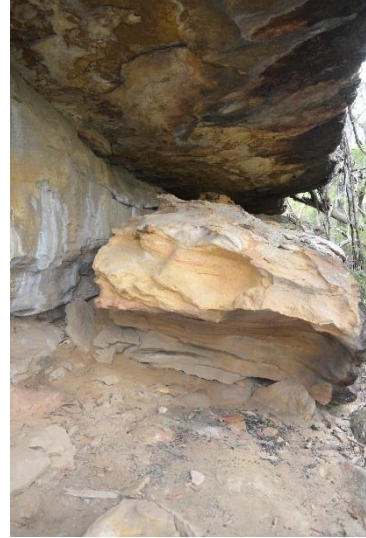
52-2-2241	Georges River 5	<p>Shelter and Art are in the same condition as described by Biosis Research 2007 and Niche Environment and Heritage 2011, 2013 and 2014. The previously reported charcoal drawings were in the same condition as described previously by Biosis 2007.</p> <p>The single quartz artefact was not observed in the shelters drip line during this assessment.</p>

General photograph of Georges River 5 facing east of boulder with infill charcoal kangaroo.
