Our Ref: 59917114\_R003: DP  
Contact: Dan Pygas

South32 Illawarra Coal

## **LONGWALL 13 END OF PANEL REPORT AQUATIC FLORA AND FAUNA REVIEW**

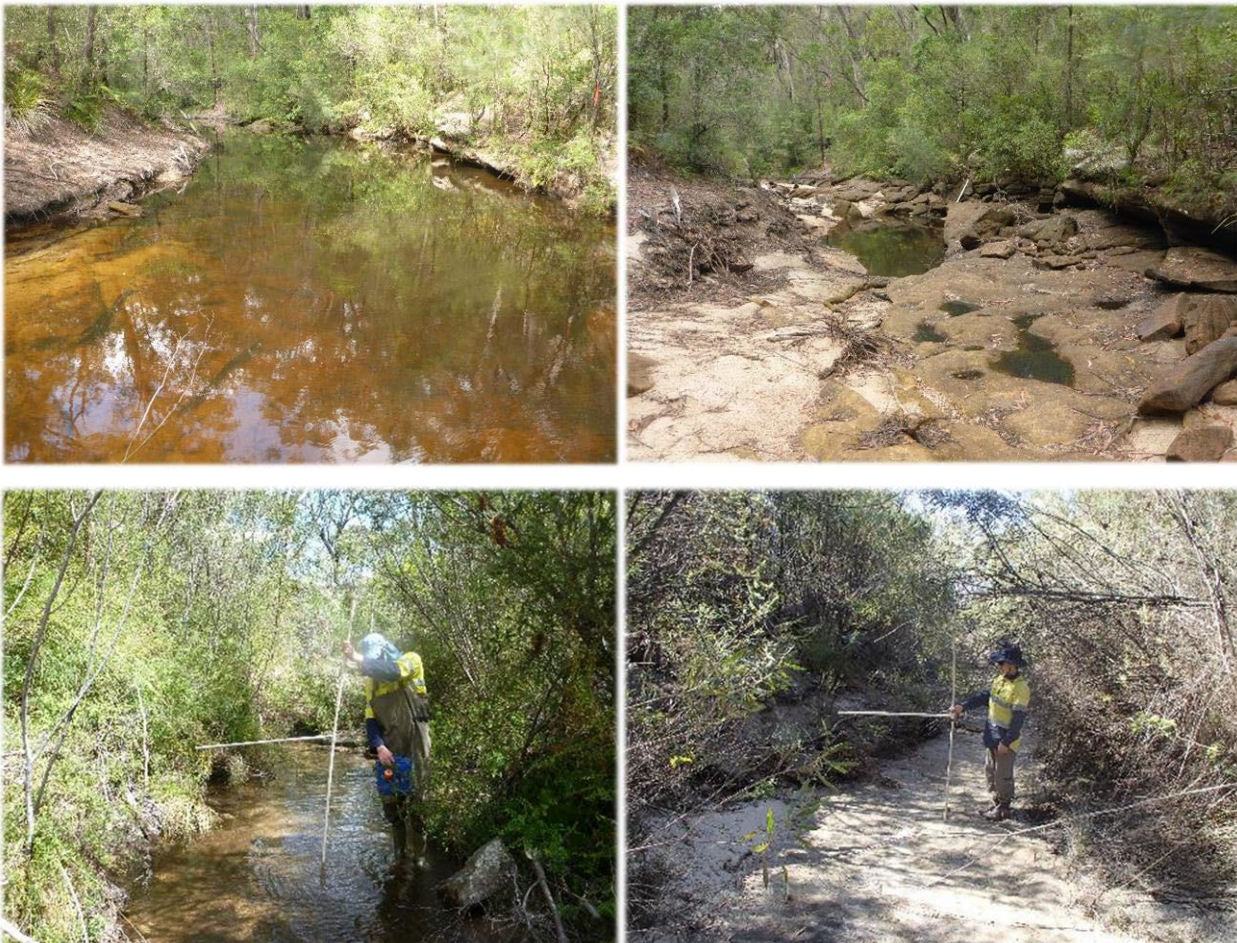
In Wongawilli Creek, several physical and water quality impacts have been observed during extraction of Longwall 13. These included an extension of the fracturing within Pool 43a, identified previously during extraction of Longwall 9 in November 2013, and a reduction in the pool water level (below the baseline level)

(South32 2017). Very low pool levels were also observed, downstream of the fracturing, in Pool 43b. These two pools are adjacent to Longwall 9. In December 2017, following a rainfall event in late November 2017, water levels in Pool 43a, and those nearby, were above the baseline level. However, in January and February of 2018, water levels in Pool 43a were again below baseline (South 32, 2018b). During this time levels in Pool 36 (just upstream of Pool 43a) were also much lower than in December 2017, with this pool appearing to be dry in February 2018. During inspections in May 2018, a reduction in flow and a series of disconnected pools were observed within an approximate 1,400 m section of Wongawilli Creek. This section was adjacent to Longwalls 9, 10 and 11 and included Pool 41 to Pool 44 (Pool 36 lies within this extent). Surface flow was observed just downstream of the confluence with Wongawilli Creek tributary WC21. No additional fracturing was observed within this section of creek.

Plate 1. Pool 43a in Wongawilli Creek in December 2017 (top left) and January 2018 (top right) (South32 2018a) and WC21 in 2012/2013 (bottom left) and in October 2017 (bottom right).

In WC21, the mining related fracturing and flow diversions first observed by South32 during extraction of Longwall 9 in December 2013 have continued to affect WC21. Several additional fractures were observed in Pools 45, 46, 47, 48, 53 and 54 in WC21 during extraction of Longwall 13 in October 2017, resulting in flow diversion and the reduction of pool levels (excluding Pool 54) (South32 2018a). The fracturing observed in WC21 during extraction of Longwall 13 has been within predictions (HGEO 2018b). By May 2018, the length of complete habitat loss in WC21 was 1 710 m, an increase of around 100 m since April 2017. Iron staining was also observed downstream of Pool 38 in October 2017.

It is recommended that further during and post mining aquatic ecology monitoring is completed in DA3B and in Wongawilli Creek and WC21 in line with the AFFR and SMP. South32 should continue to monitor watercourses that have been affected by extraction of Longwall 13 and previous longwalls and the findings of these will be used to assess whether TARPs will subsequently be triggered. Further assessment should also be undertaken to determine what component of reductions in flow and water levels in Wongawilli Creek is attributed to patterns in rainfall and physical mining impacts.
