BULLI SEAM OPERATIONS

SECTION 6 REHABILITATION AND MINE CLOSURE

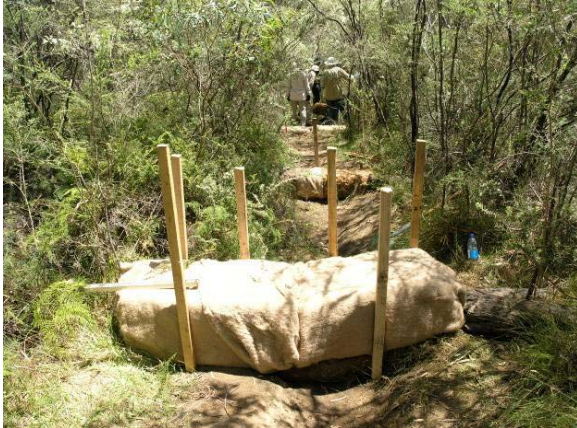
A trench is cut into the swamp soils such that the first layer of coir logs sits on the underlying substrate or the top of the first coir log is at ground level. The coir logs are held in place by wooden stakes and bound together with wire. The coir log dam slows water flows, allowing siltation behind the log dam (Good *et al.*, unpublished). The small coir log dams are constructed at intervals down the erosion channel. Where increased filtering of flows is required, the coir logs can be wrapped in jute fibre matting as shown in Plate 6-2.

Plate 6-2 - Small Coir Log Dams Constructed at Intervals along an Incised Swamp with Jute Wrapping

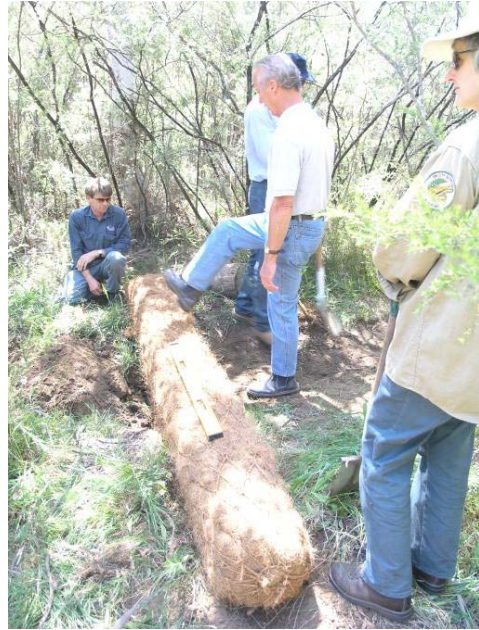
The maintenance of the swamp moisture regime can also be enhanced by additional water spreading techniques, involving long lengths of coir logs and hessian 'sausages' linked together across the contour such that water flow builds up behind them then slowly seeps through the water spreaders (Good *et al.*, unpublished). The water spreaders can be positioned as required within shallow trenches within a swamp (Plate 6-3).

Plate 6-3 - Round Coir Logs Installed to Spread Water

Erosion control and water spreading involves soft-engineering materials that would contribute to and function as part of the swamp system but would eventually degrade (totally biodegradable) and become integrated into the soil/organic matter complex of the swamps (Good *et al.*, unpublished).
