Our Ref: NE30130_R011: DP
Contact: Dan Pygas

South32 Illawarra Coal

APPIN AREA 9 LONGWALL 904 END OF PANEL REPORT - AQUATIC FLORA AND FAUNA REVIEW

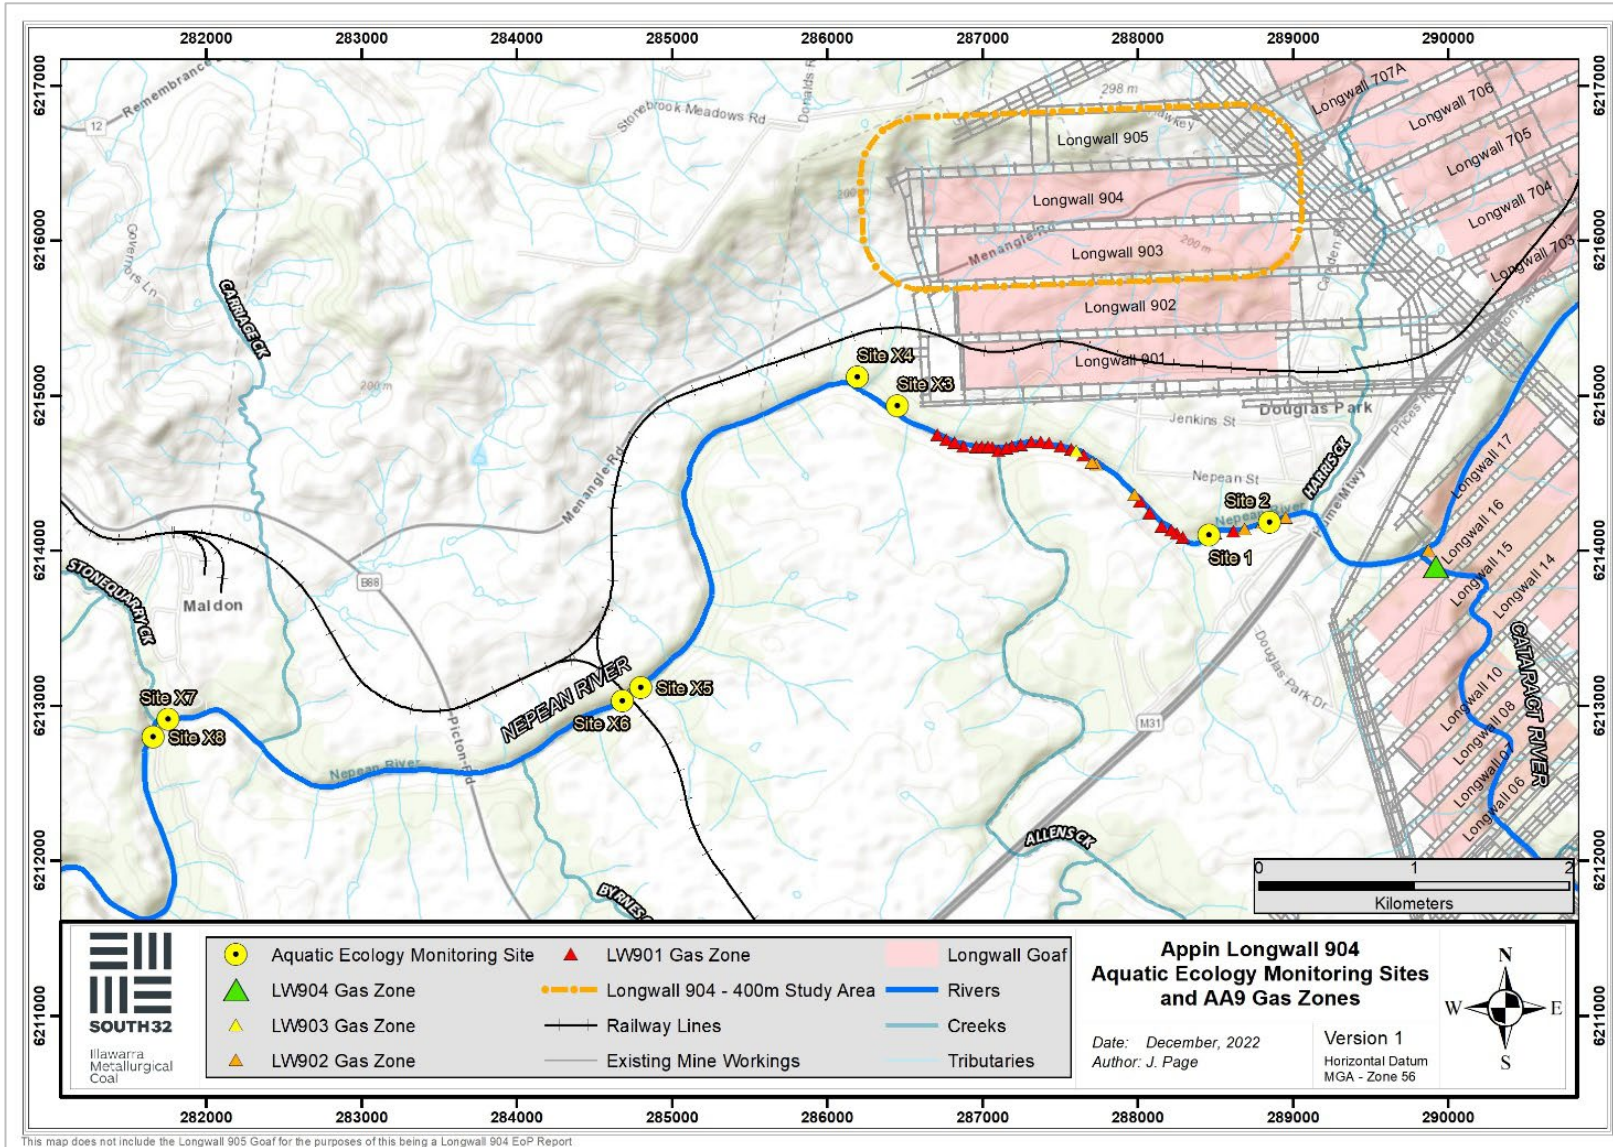
Figure 1-2 Location of gas releases and monitoring sites in the Nepean River adjacent to Longwalls 901 to 904.

These indicators are assessed at two potential impact sites (X3 and X4), located on the Nepean River near its closest point to Appin Area 9 longwalls, and at control sites (X5 to X8) farther upstream on the Nepean River. Sites 1 and 2 located just upstream of Douglas Park Weir also provide a measure of potential downstream impacts. These sites are monitored annually for Appin Area 7. **Figure 1-2** shows these Nepean River sites in relation to Appin mining operations.

IMCEFT identified one new gas release zone in the Cataract River during extraction of Longwall 904 (South32 2022). The confluence of the Cataract River with the Nepean River is approximately 2,600 m from the closest point of Longwall 904 and approximately the same distance downstream of Sites X3 and X4 (**Figure 1-2**). This had an approximate area of 15 m² and was first observed on 1 August 2022 but was inactive during observation on 5 September 2022. As of 5 September, five gas release zones previously observed during extraction of Longwalls 901 and 903 were active in the Nepean River. Gas release zones have been observed from Site 2 upstream to Site X3. These gas release zones typically occur over areas of under approximately ten square metres, whilst larger zones of light releases can occur scattered over areas up to several hundred square metres.
